# Manhole Inspection Summary

Manhole # S19CC1003MH

Insp Date: **3/13/07 9:51 AM**

**Location** Address: **2122 DRUID PARK DR**

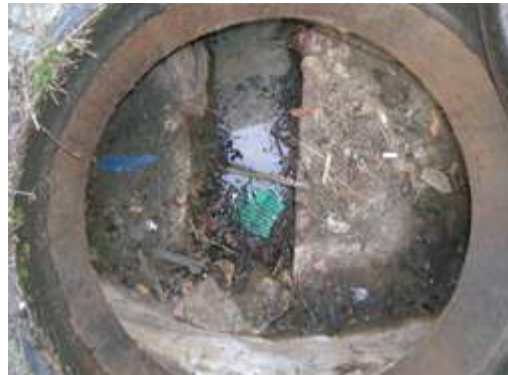
Top View

Bench and Channel debris.

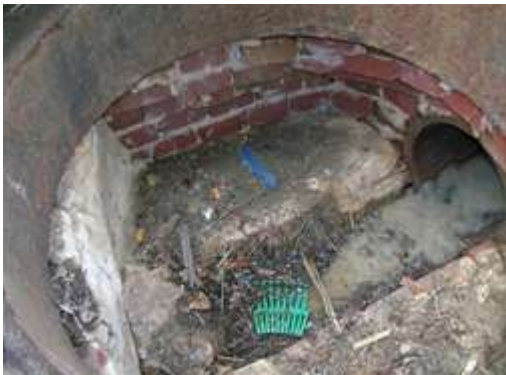
Defect

**Frame** Offset: **0** (in.) Condition: ☐ Sound ☐ Cracked ☒ **Leaks**

Infiltration: ☐ None ☒ **Joint** ☐ Cracks ☐ Mortar ☐ Roots ☒ **Wall**

Infiltration: ☐ None ☐ Joint ☐ Cracks ☒ **Mortar** ☐ Roots ☒ **Wall**

Frame leaks. Corbel and Barrel infiltration.

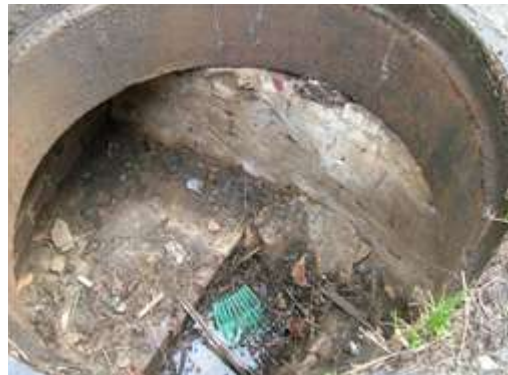
Defect

Frame leaks. Corbel infiltration - other side.

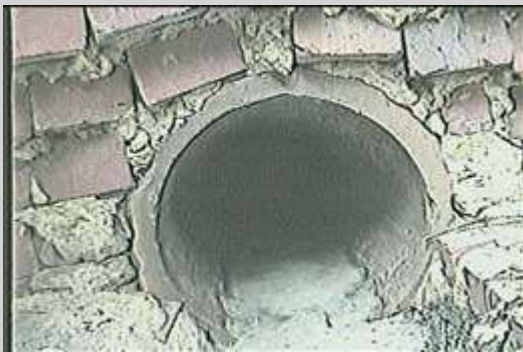
10 in. Circular Gravity Sewer  
Pipe Out @ 12 O'Clock

Condition: ☐ Sound ☐ Cracked ☐ Root Intrusion ☐ Loose Brick ☒ **Deteriorated**

Barrel deterioration.
